Massachusetts Department of
Environmental Protection

The Occurrence and Sources
of Perchlorate in Massachusetts

August 2005

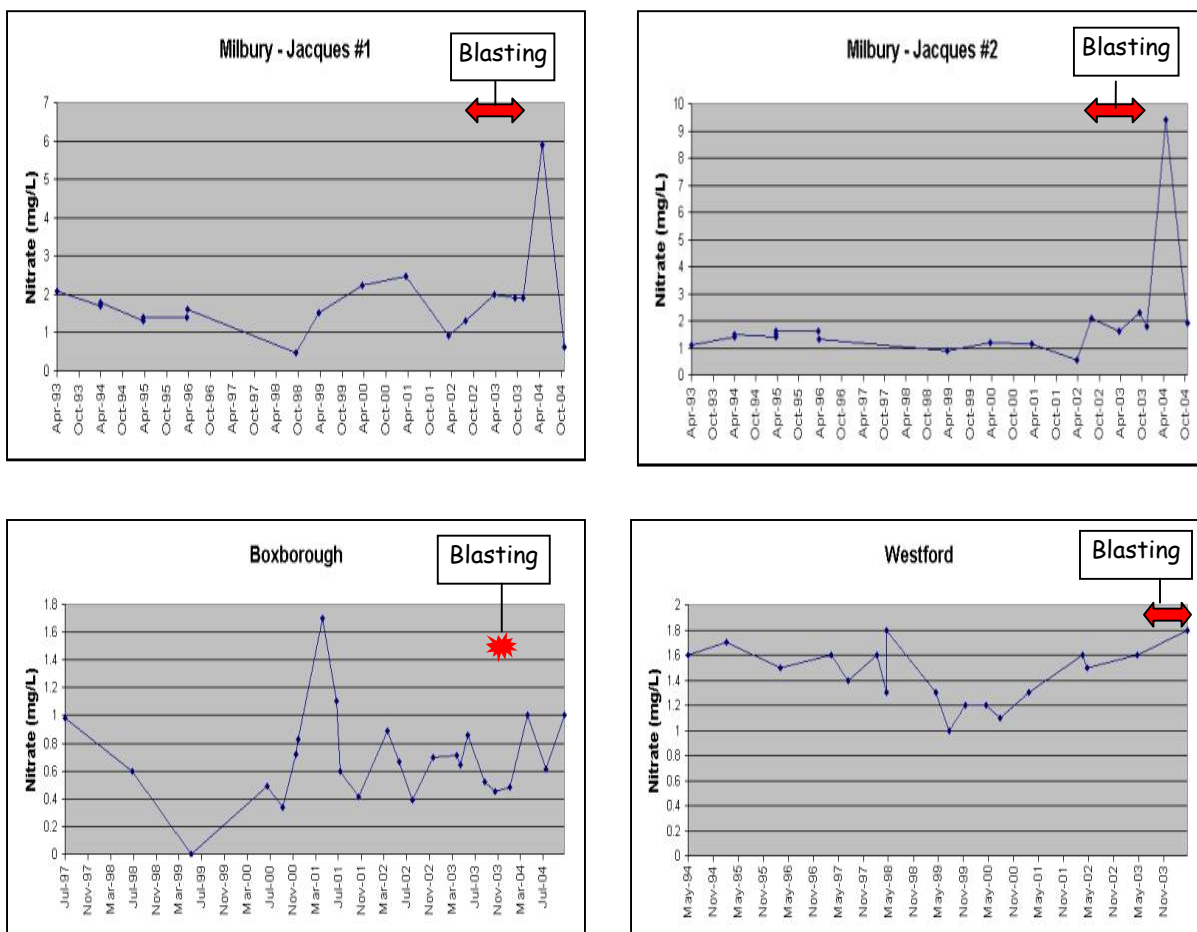
Figure 6
Nitrate Levels in Wells Impacted by Perchlorate from Suspected Blasting Sources

Figure 6 plots the last 10 years of routine nitrate monitoring data for the 3 blasting-related impacted water supplies.

The above data suggest the possibility of a relationship between nitrates and perchlorate at the Millbury site, given the 5-10 fold increase in nitrates in Jacques Wells #1 and #2, located 800 - 1000 feet to the east of the mall construction site, approximately 18 months after the start of blasting activities. This is also the site where large amounts of ANFO were used (621,000 pounds).

A relationship between perchlorate and nitrate is not evident in the monitoring data for the Cote Well in Westford. This well is the most distant (2600 feet) and least impacted ($3.7 \mu\text{g/L}$) of the three blasting sites. Given these characteristics, and the fact that blasting did not begin until August 2003, it is possible that peak concentrations of both contaminants have not as yet been seen.

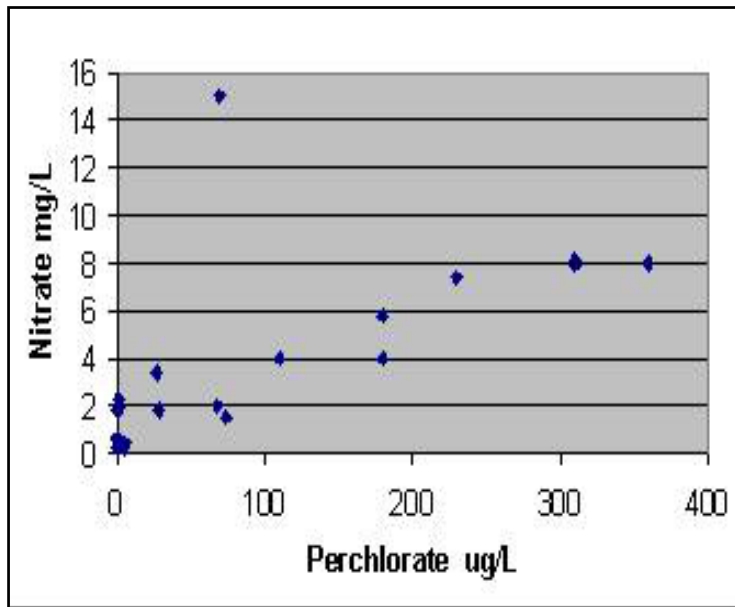
Figure 7
Millbury, MA Perchlorate vs Nitrate
(GeoSyntec, 2005)

This relationship was further explored by the consulting firm overseeing work at the Millbury site, during a series of sampling events in February 2005, where split samples were analyzed for perchlorate and nitrates ($\text{NO}_3\text{-N}$). In total, 22 samples were synoptically analyzed in this manner, including 8 drainage/surface water samples, 8 overburden groundwater samples, and 6 bedrock groundwater samples. The results of all data are plotted in Figure 7. Once again, the possibility of a general correlation is suggested, though more evaluation of variables (e.g., site-wide explosive materials usage, precipitation events, groundwater elevations, etc.) would be needed to draw more definitive conclusions.

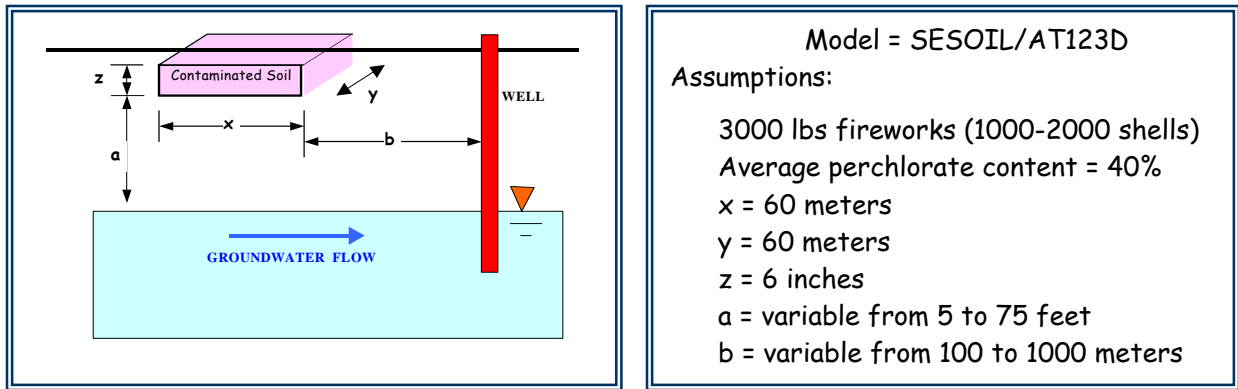
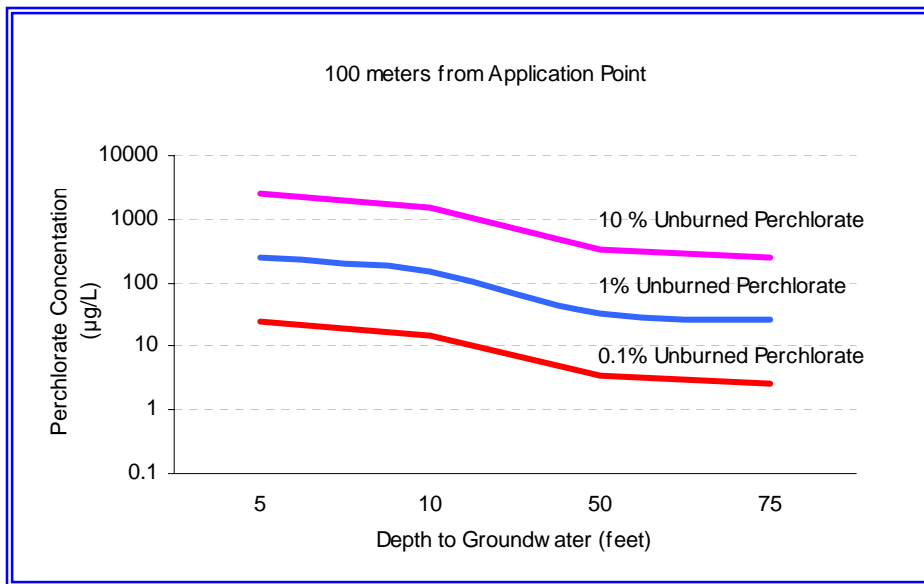
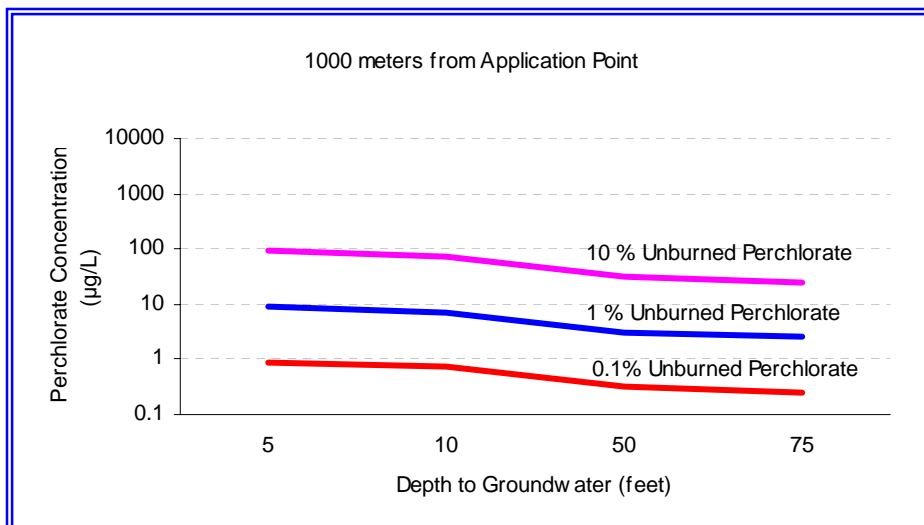
Figure 8: Modeled Perchlorate Impacts to Groundwater from Fireworks Display

MADEP has conducted limited modeling efforts of hypothetical fireworks displays, in order to better define the scope and range of potential groundwater impacts and concerns. The details and results of this modeling effort are contained in Figure 8, which assumes a mid-sized "July 4th community display" of 1000 to 2000 aerial shells, with a total weight of 3000 pounds.

Additional Model Inputs:

- 44 inches of precipitation per year (Massachusetts)
- Solubility of Potassium Perchlorate = 1.5×10^7 µg/L
- Hydraulic Conductivity = 4.583 m/hr (sand)
- Hydraulic Gradient = 0.0031

While the 40% perchlorate figure may be high, it is being used in the absence of anything more definitive from the pyrotechnics industry. On the basis of this analysis, even with 99.9% destruction of perchlorates, tens of $\mu\text{g/L}$ of perchlorate could be expected immediately (100 meters) downgradient of the fallout area, with trace amounts ($1 \mu\text{g/L} \pm$) further downgradient. Higher concentrations could be expected with larger displays, use of pyrotechnics with higher amounts of perchlorates, less complete combustion, improper disposal of duds and misfires, excessive debris fallout and/or lack of post-display cleanup.
